# **NUMALIGARH REFINERY LIMITED**

## **INVESTIGATION REPORT OF MINOR FIRE INCIDENT AT CDU/VDU**

**Date of Incident: 02.05.2015**

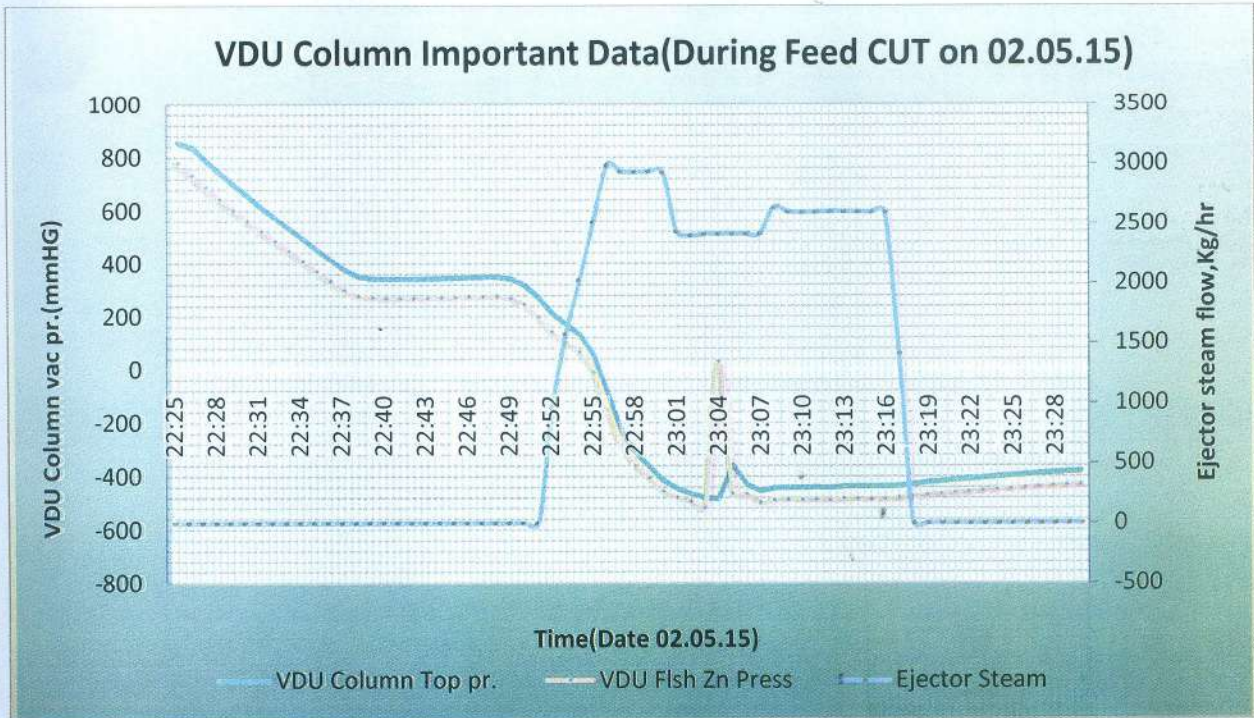
## Column Flash Zone Pressure Trend-1

- At the time of incident there was sudden increase in flash zone pressure from -518 mmHg to +29 mmHg (at 11.04 pm within 30 seconds). Thereafter again vacuum was restored to -501 mmHg (at 11.06 pm).

This effect of the 42" transfer line was due to the probable explosion that took place inside the transfer line or at the flash zone of VDU column. The location of said explosion can be ascertained from the fact that the trend of flash zone pressure of the VDU column (Refer Trend-1 in **ANNEXURE - I**) at the time of incident that shows sudden high pressure spike, which can only be caused by violent pressure charge from an explosion inside. During the incident period, steam flow to ejector system was steady and that shows no sudden vacuum break from the ejector side. The sudden positive pressure spike in flash zone (higher compared to column overhead), indicates location of explosion is near the column flash zone. Same is substantiated from the fact that sound was heard near the VDU column.

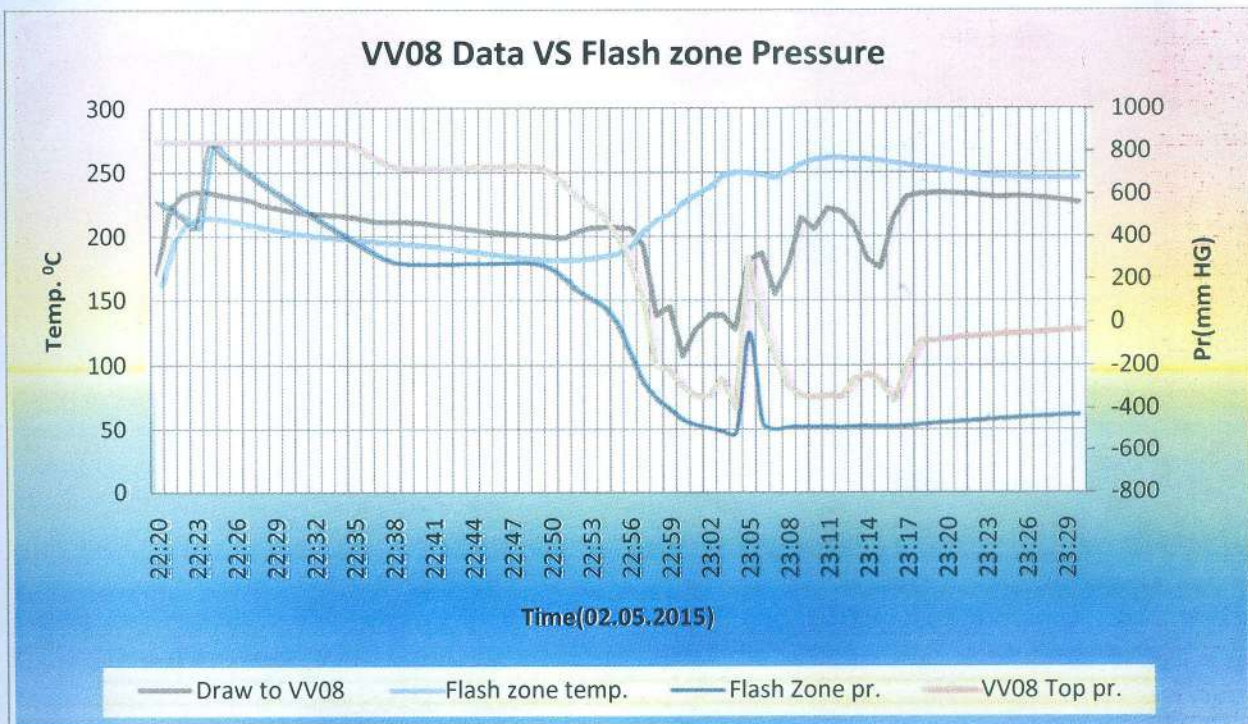
## VV-8 draw Temperature &amp; Flash Zone temperature, Trend-2

- Drastic change on slop cut to VV-08 draw off temperature (CTI2107) was observed, which came down significantly to 107 °C from around 207 °C just before the incident took place. VV-08 bottom pump PA-21A/B was on stop condition at that time.

It has been observed that initially the draw off temperature (CTI-2107) of VV-08 was increasing gradually with the increase in FF-2 COT and the subsequent increase in flash zone temperature. However, just before the time of the incident it came down significantly after starting of vacuum pulling (Refer Trend-2 in **ANNEXURE - I**), which indicates back flow of cold fluid (either air or condensate) through the line from VV-8 or from PA-21 A/B suction line. As vacuum pulling rate was high, sufficient cold fluid ingress into the hot system (inside VDU column) may have influenced the explosion. Here it is to be noted that PA-21A/B was not started on that day and the isolation valve in the minimum circulation flow line was found wheel free and the Low-point-drain nozzle in that line with  $\frac{3}{4}$ " valve was found in closed position but not in blinded condition.

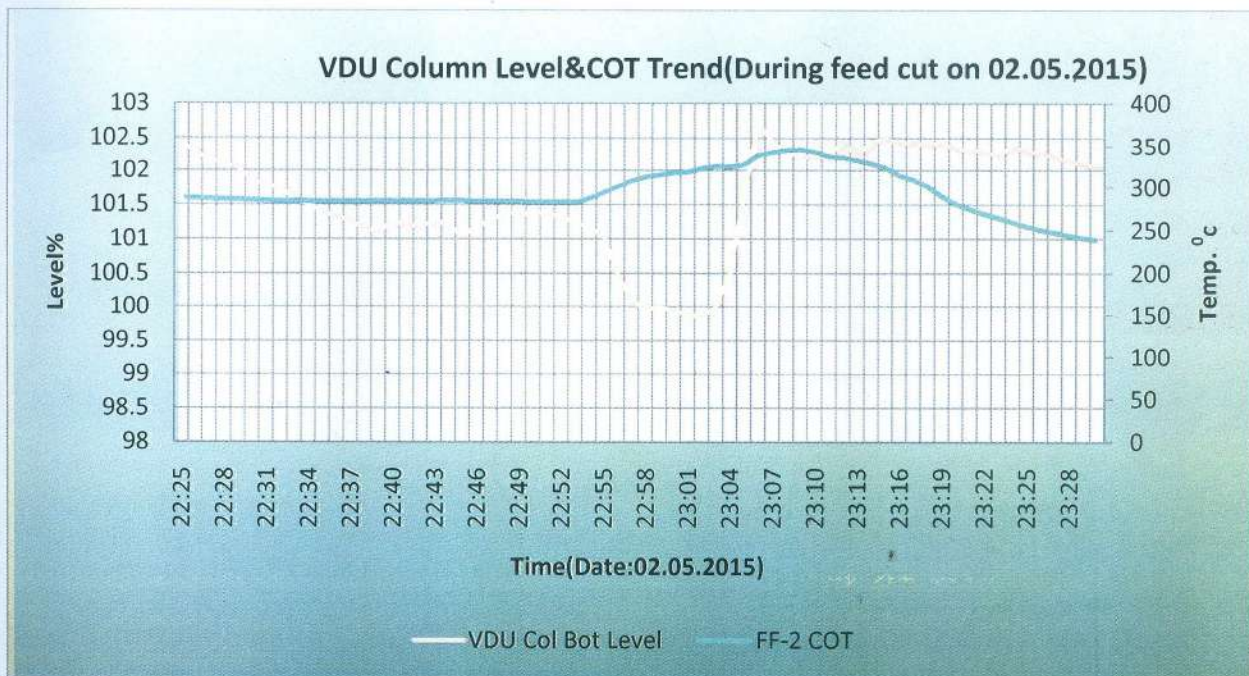
### Column bottom Level and Flash Zone Temperature, Trend-3

- Level in CC-06 bottom was high and was more than 100 % since 22:23 hrs. Although it came down once to 99.9% at 22.58 hrs but it remained more than 100% during the incident period also.

In case of very high level in the vacuum column bottom and subsequent rise of level build up may cause damage inside. However, though the column bottom level was at 100% most of the times, but it was observed that level came down to 99% at 20.58 pm to 11.03 pm (Refer Trend-3 in **ANNEXURE - I**), which indicates that liquid hold up at column bottom was not high enough to build any flow disturbance through the transfer line. Also no other indication of flooding at flash zone was found as well as the stripping steam was not introduced into the column during the time.

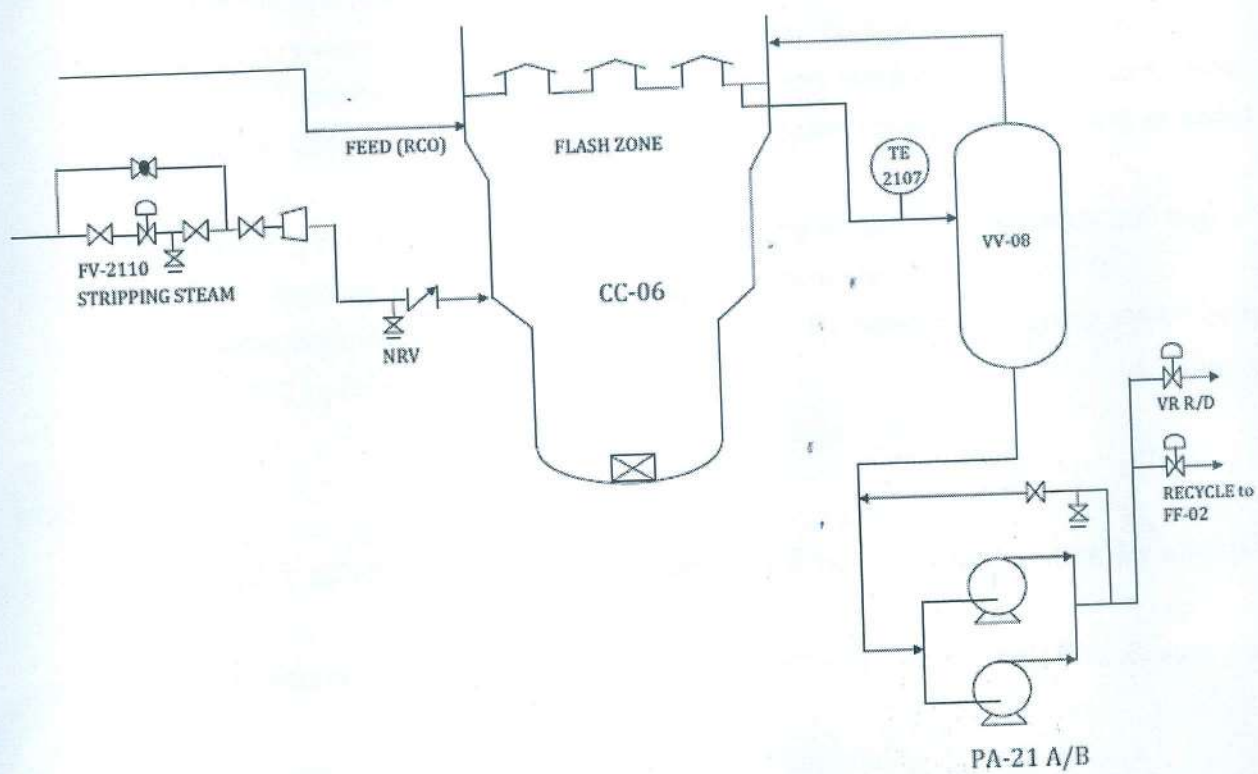
SCHEMATIC DIAGRAM: VDU COLUMN BOTTOM

Slop distillate pot (01-VV-008) remains in floating condition with the VDU column just above the flash zone during operation. The draw-off line from CT-1 comes to the upper part of the vessel and the vapor return line from the vessel top goes back to VDU column above CT-1. From bottom of the vessel, the line goes to VR + Slop recycle pump suction (01-PA-21A/B) and from the pump discharge, one part goes to VR rundown and the

Here, if the condensate in this line is not sufficiently drained through these two low point drains, there is a possibility of condensate trapped in the portion from d/s of the control valve to the u/s of the NRV. During initial hot circulation of the column, the system remains at positive pressure (about 0.5 Kg/cm<sup>2</sup>) and as a result the NRV flapper is at closed condition due to the back pressure from the column side when there is no sufficient steam flow. However with the starting of the vacuum pulling due to negative pressure created in the system may lead to open up of the NRV flapper allowing the trapped condensate to move to the column inside causing water shot / hammering effect due to sudden expansion of the low temperature condensate subjected to the high temperature exposure inside the column. It is to be noted that the low point drain at the upstream of the NRV was found choked and indicates that condensate draining through this LPD might not have been done before start up.

For the above two points, please refer the sketch for VV-08 & the Stripping steam injection to VDU column, attached as **ANNEXURE – II**.

(V) One modification is to be done with proper MOC for providing steam trap & b/p valve (Drip-leg assembly) at the existing low point drains at Striping steam line to vacuum column (at CV d/s and at u/s of the NRV).
