Subject:      **Enquiry Committee Report**

**INVESTIGATION REPORT OF THE FIRE INCIDENT**  
**ON 11<sup>th</sup> May '2015, IN HCU**

1.1 While starting up Hydrocracker Unit (HCU) after the recent refinery turn around, a fire broke out at around 11:09 am on 11/05/2015, due to leakage of upstream flange of downstream isolation valve of pilot operated PSV (04-PSV-8301B) of cold high pressure separator (04-VV-004). Emergency shutdown of Hydrocracker Unit was taken safely and fire was immediately brought under control. Hydro carbon contained in the separator was allowed to be safely burnt under controlled condition. Since the HCU start up process was aborted, consequently shut down of the Hydrogen unit was taken. Fire was extinguished at around 11:45 am. However, cooling of the nearby area was continued till around 1.30 pm.

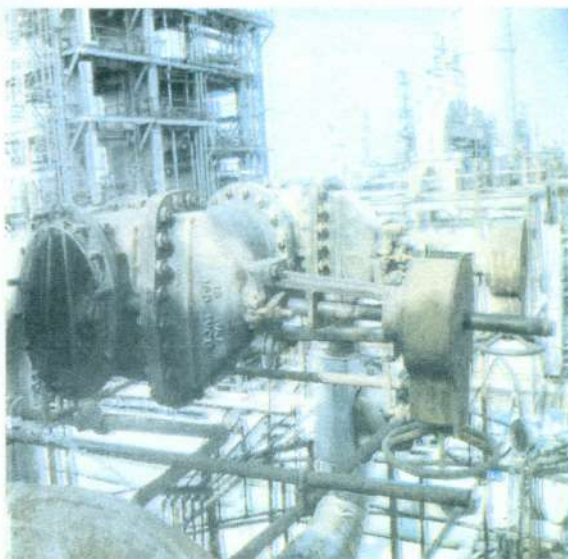
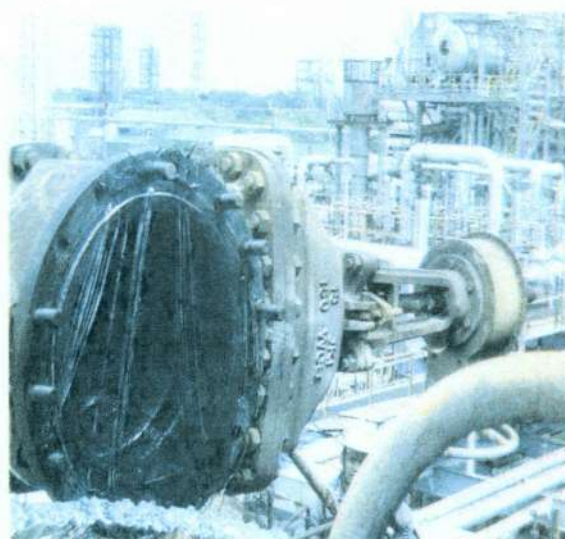
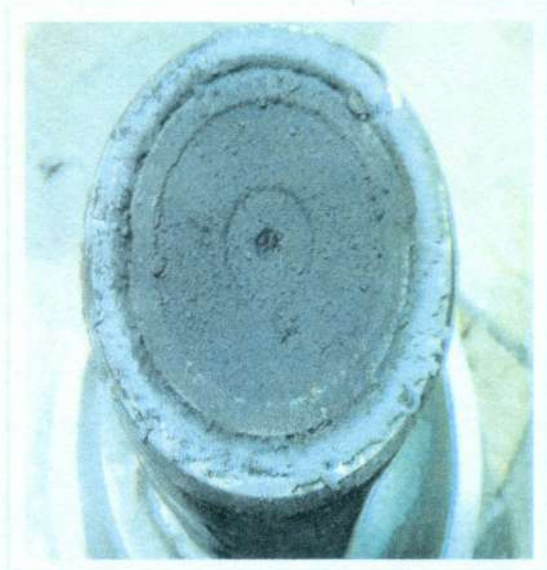
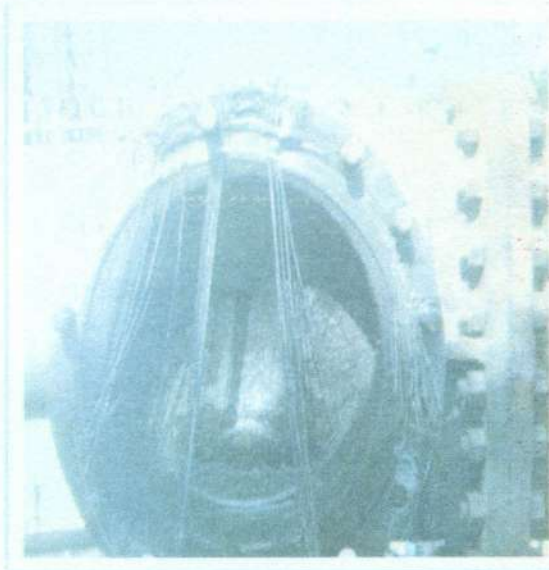
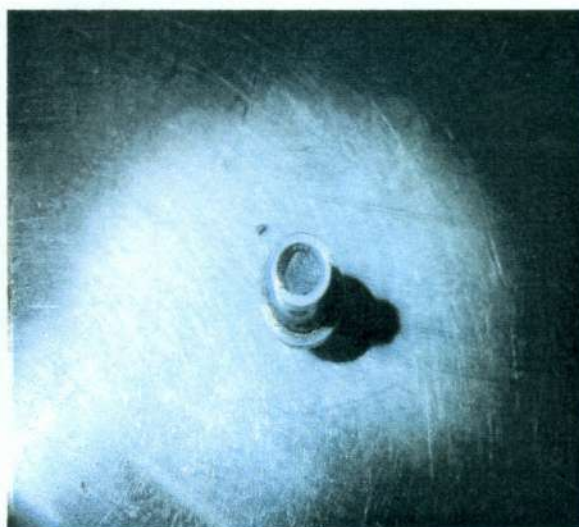
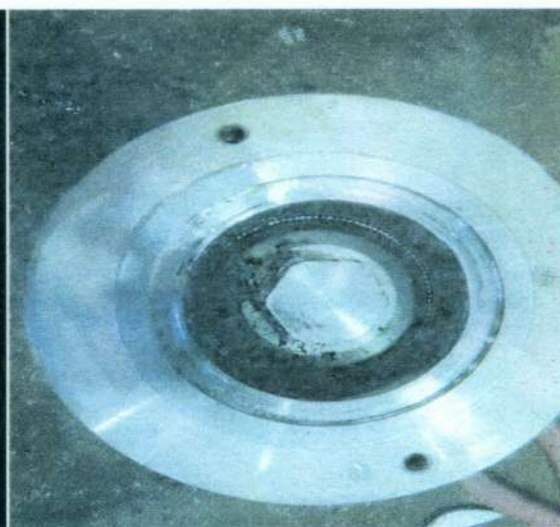
ANNEXURE-IV

- i. After dismantling of PSV-8301B from position, it was observed that the gate of the downstream isolation was in closed position although the spindle (rising stem type) of the valve was in open position. The valve wheel was found free to rotate.

- ii. It is pertinent to note that the valve wheel of the downstream isolation of PSV-8301A was also found to be free to rotate even though in this valve the stem was not dislodged from the gate.

- iii. The affected gasket was found to be in blown out condition. The gasket was compatible to pipe spec.
- iv. Visited central workshop and checked testing records of both the aforesaid PSVs and found to be in order (set at 167.2 Kg/cm<sup>2</sup>g).

- v. Calibration records of the PSV test bench pressure gauge was found in order.
- vi. On dismantling, the tubing connecting the pilot valves to the dome of both the PSVs were found completely choked at the upstream of the NRV mounted on the dome. Photographs attached as annexure-III. Such deposits were also found inside the dome of the PSVs.

- 7.1 Ensure opening of d/s i/v at the time of box-up of PSV, by watching that in case of rising stem type, while opening the valve stem/spindle is not rotating, only stem is coming out. Accordingly an SOP should be developed and implemented to eliminate the chances of downstream gate valve remaining closed when the related PSV is online.

- 7.2 PSV-8301A/B downstream isolation valves should be kept lock open (LO), as per P&ID (refer E-183B R6, Cold High Pr Separator).
- 7.3 It is learnt that later designs of such pilot operated PSVs are provided with strainer on the upstream of the pilot inlet. Manufacturers / process licensor to be approached in respect of this.
